Re: Proposed Asphalt Plant by Royel Paving, in Irondale, Ontario

Concerning the existing aggregate extraction operation and proposed asphalt plant by Royel Paving, in Irondale, Ontario I would like to make the following points:

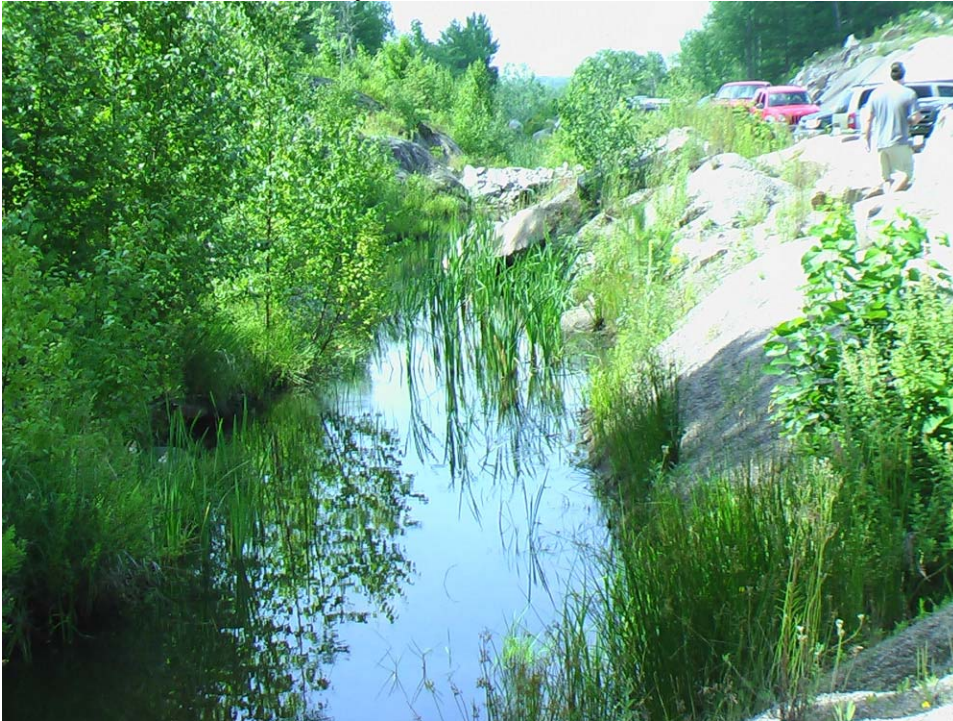
Photo 1 Stream Habitat, July 15, 2006

- The lower end of the stream, near the highway is clearly permanent stream habitat (there is water in it now during the hottest time of the year) and this existing habitat is at risk of harmful alteration, disruption or destruction of fish habitat from upstream land-use activities.

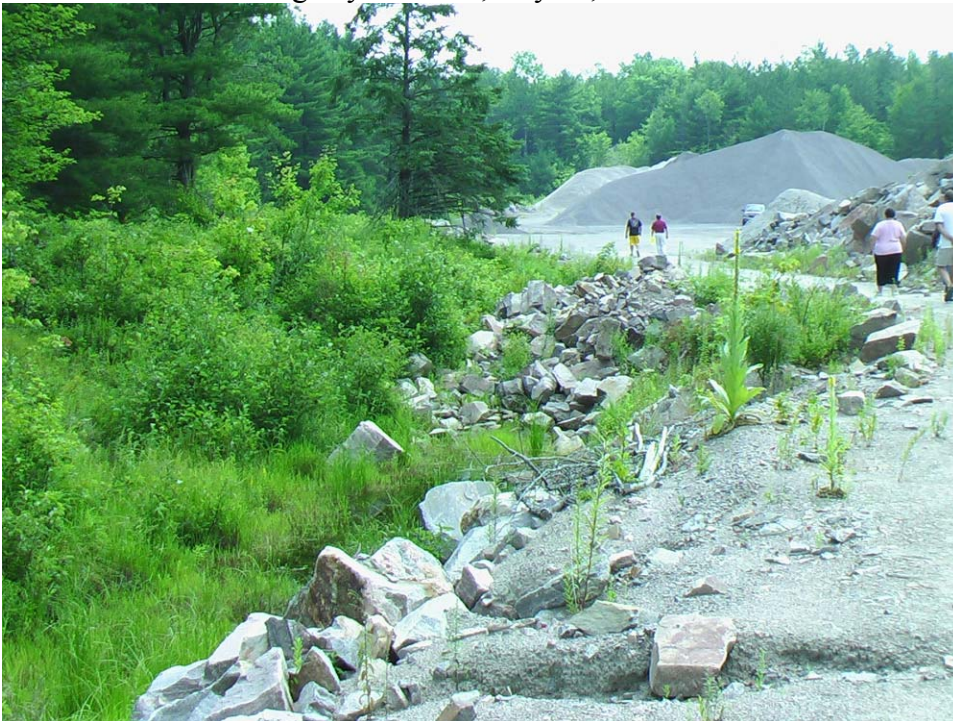
Photo 2 Stream blockage by boulders, July 15, 2006

- Coarse rock obstructions that prevent passage by fish would have been unnecessary as preventative measures against siltation and for stabilization of nearby roadbed if the workyard was further away from the stream. A lower-ratio slope dressed with topsoil and planted with riparian vegetation would have achieved all drainage objectives while at the same time preventing siltation and other runoff concerns and creating viable fish habitat. Not only was destruction of the original ponds unassessed and unjustified, but there has been a missed opportunity to mandate creation of stream habitat as compensatory measures. Already, the stream has been colonized by frogs, snakes, aquatic plant species, etc. but because of its poor design it has significant impairments built into it; those being the potential for sedimentation, and the presence of coarse rock barriers.

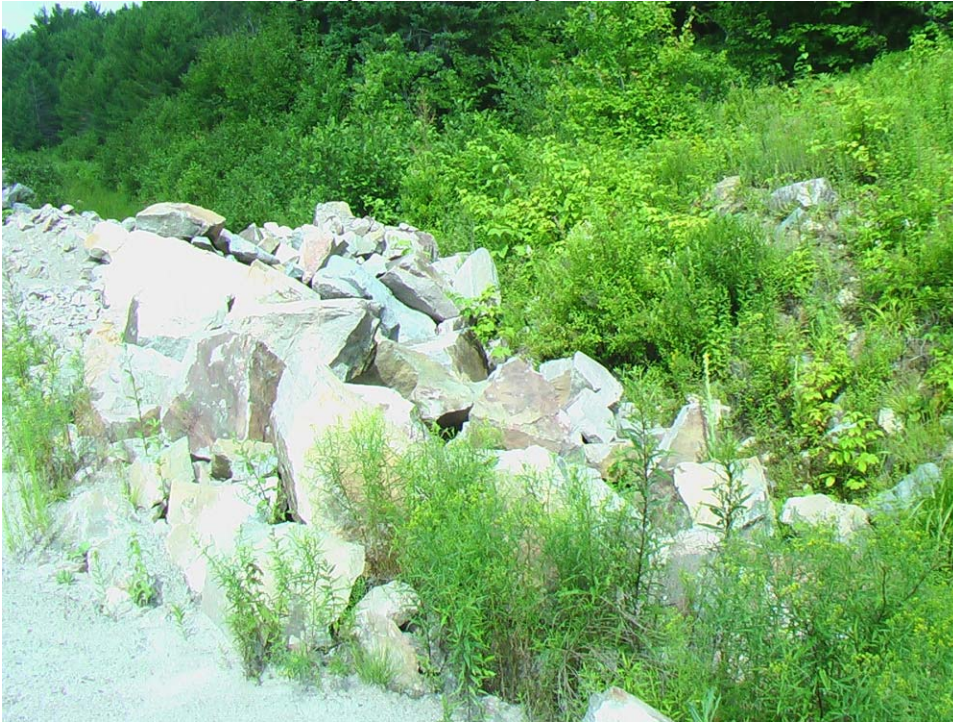
Photo 3 Stream blockage by boulders, July 15, 2006

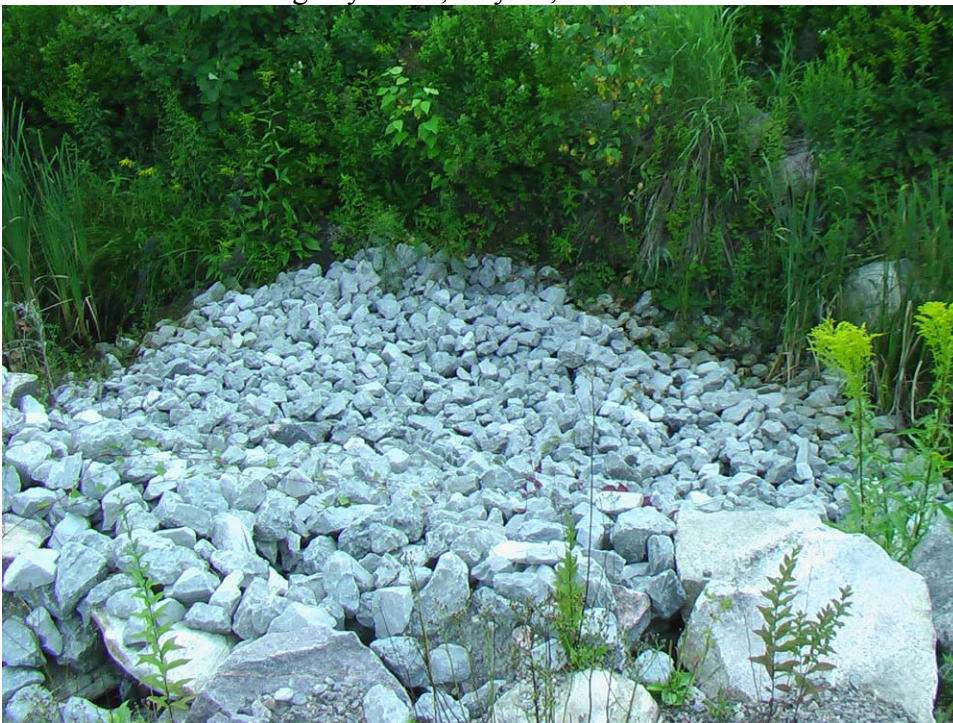
Photo 4 Stream blockage by rocks, July 15, 2006

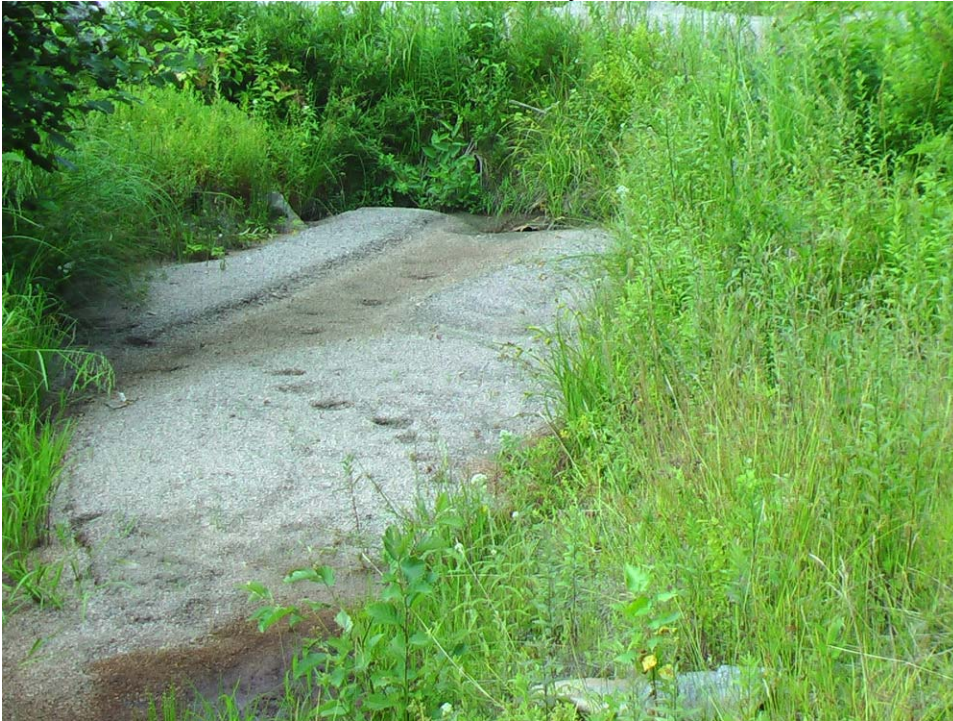
- The working yard of the aggregate operation is too close to the new stream.
- Heavy sedimentation from run-off is occurring in the stream particularly at the culverts (see accompanying photos).

Photo 5 Stream sedimentation at culvert, July 15, 2006

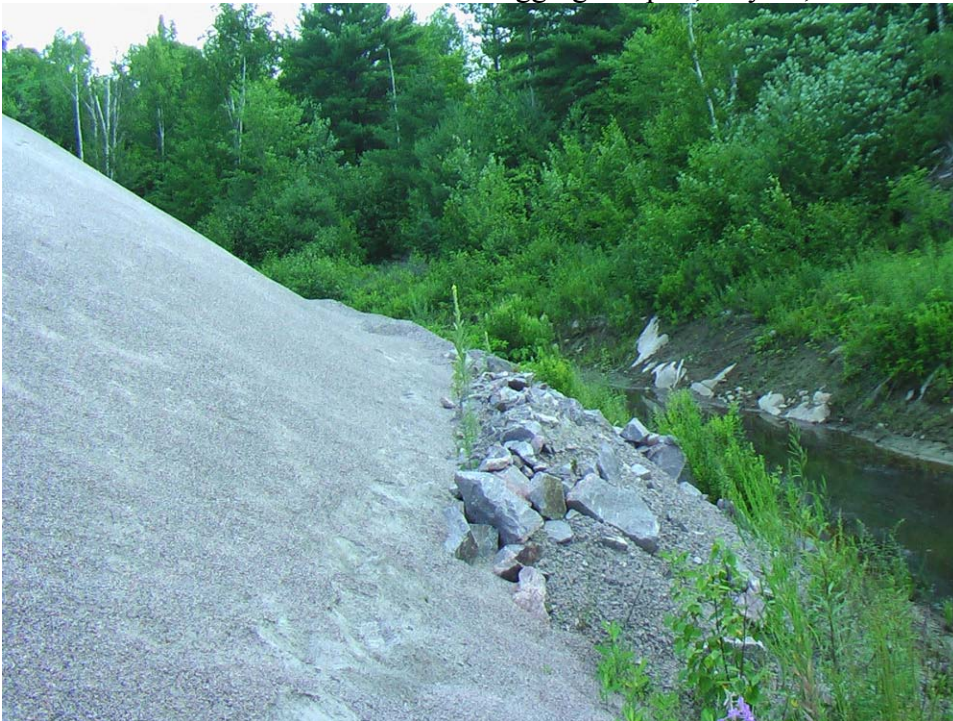
- The main pile of aggregate screenings is immediately adjacent to the stream at a very steep slope that would be conducive to mass movement (see photos).

Photo 6 Stream at risk from erosion of aggregates pile, July 15, 2006
